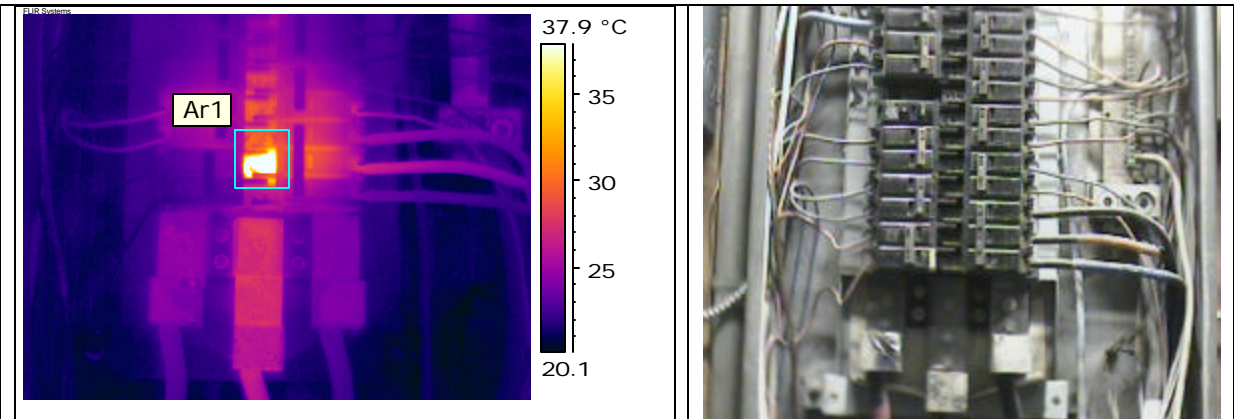
IR Text Comment Value	Label Value
Location Upstairs Large Elec Room	IR: Date Of Creation 06-12-05
Designation Pnl 220B	IR: File Name IR_120506_017.JPG
Component 100A Breaker	Ar1: Max 61.6 °C
Fault warm Line Side Connection	
Recommendations Remove brk, clean connection, re-install, re-scan

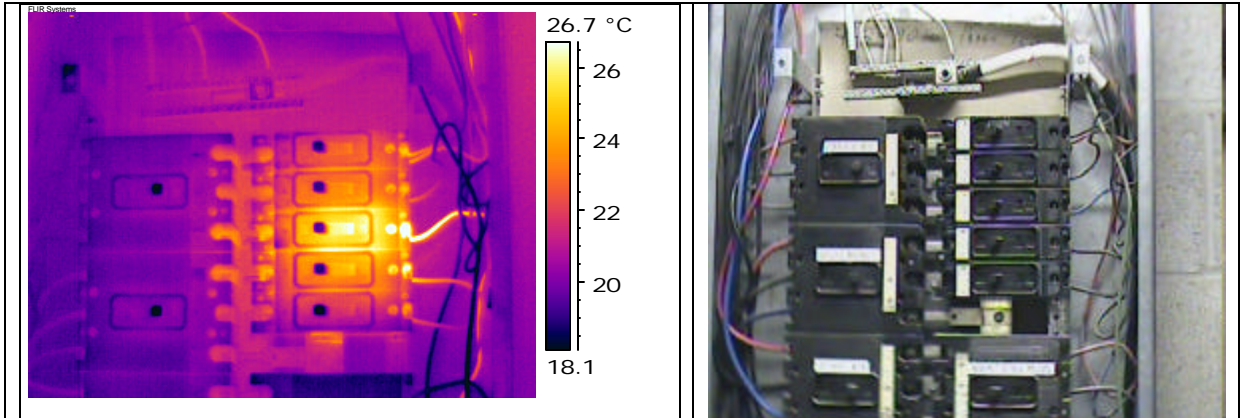
IR Text Comment Value	Label Value
Location Upstairs Large Elec Room	IR: Date Of Creation 06-12-05
Designation Panel 100	IR: File Name IR_120506_023.JPG
Component 15A Breakers	
Fault Overloaded Circuits	
Recommendations See comments below

Single pole 15amp breakers appear to be un-balanced. Couple of these single pole breakers have 18amps on them. The neutral conductor has 15amps on it. The top right breaker was in the tripped position when we found it.

Trace out circuits and re balance loads.
